Dicing Technology In Super-Thin Wafer For IC

Jian Jiang, Chunlan Song, Zhenglin Zhang

Wuxi China Resources Microelectronics Co., Ltd., China
14 Liangxi Road, Wuxi, Jiangsu, PRC 214061

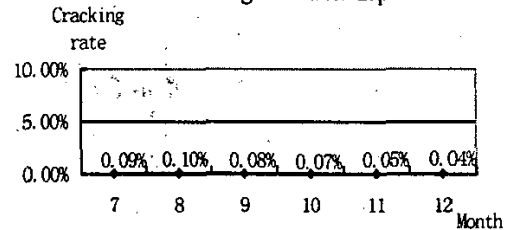
Fig5.

Cracking Rate after Improvement

Month after improvement	July	August	September	October	November	December
Number of Chips	12821	15394	13942	19896	17785	18416
Number of face side cracking chips	12	15	11	14	9	8
Cracking rate	0.09%	0.10%	0.08%	0.07%	0.05%	0.04%

Table2

Production practice proves that cracks on both side of face and back can be avoided in this way above-mentioned.

In the early stage of production, the yield only reaches 85%. After improving on process the yield reaches 90%-98% which can not meet the needs of customers yet. But now, the yield can reach over 99.9% as a result of our researching and exploring for dicing technique.
